Loss Control Field Inspection

The Michael White Adobe
San Marino Unified School District
San Marino High School
2701 Huntington Drive in San Marino, California

August 12, 2008

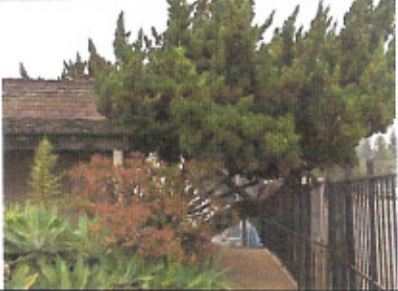
<p>08-08-01 Trees encroaching on the roof of the building create a fire hazard as well as providing building access to vandals.</p> <ul style="list-style-type: none"> • Trim or remove trees that exceed fence lines and make contact with exterior portions of the building.

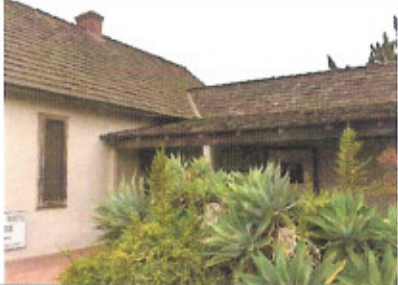
<p>08-08-02 Excessive brush growth, provides a haven for vermin as well as a hiding place for trespassers.</p> <ul style="list-style-type: none"> • Maintain decorative shrubs and plants to a level below 18 inches high.

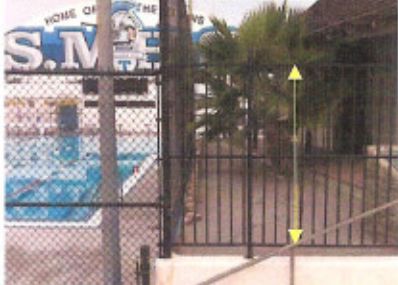
<p>08-08-03 Close proximity of the Adobe to the school swimming pool and parks creates an attractive nuisance to students and patrons.</p> <ul style="list-style-type: none"> • Ensure that only authorized persons enter the Adobe area. • Exterior fence height should match the fence height adjacent to the swimming pool.

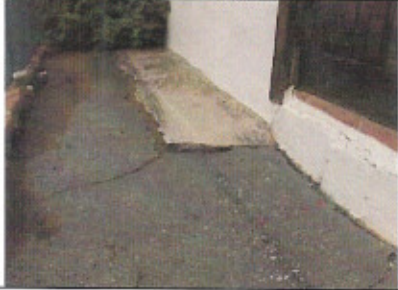
<p>08-08-04 Exterior walking surfaces surrounding the Adobe are cracked and uneven, presenting a trip and fall hazard.</p> <ul style="list-style-type: none"> • Repair cracked and uneven surfaces surrounding the Adobe. Surfaces should be smooth and level.

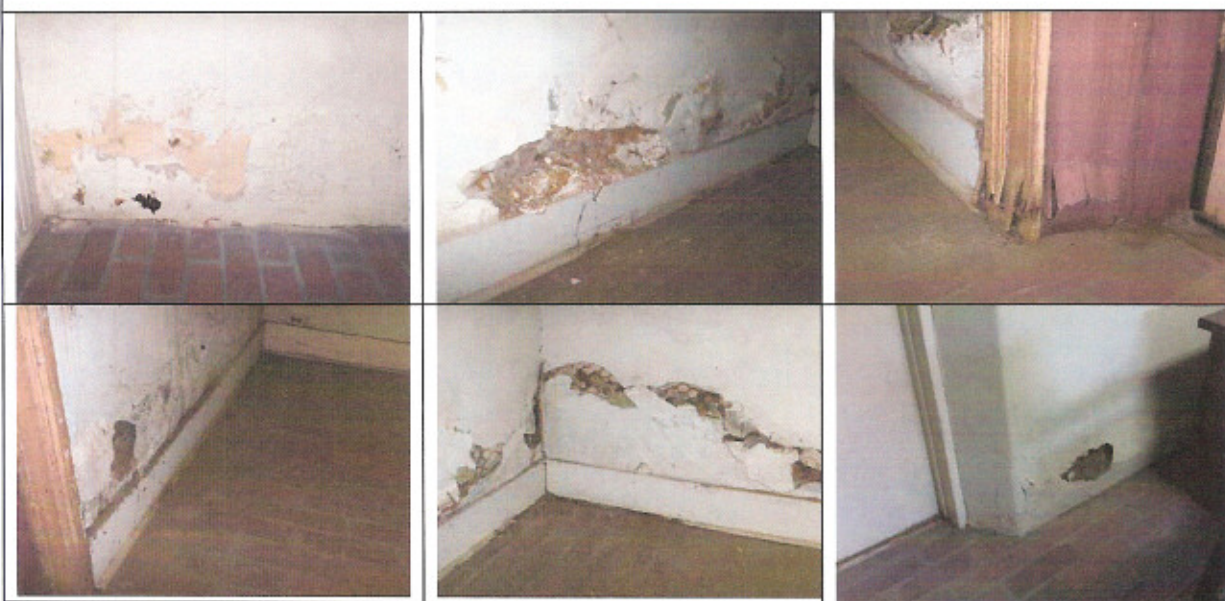
Interior areas of the Adobe indicate water damage and termite infestation. Most interior walls contain significant horizontal cracks near the base. Crumbling adobe is present near horizontal cracks and the building foundation.

The photos above indicate significant water damage to the interior portions of the building, including ceiling areas. It is not apparent the effect water damage has had to the structural integrity of the building.

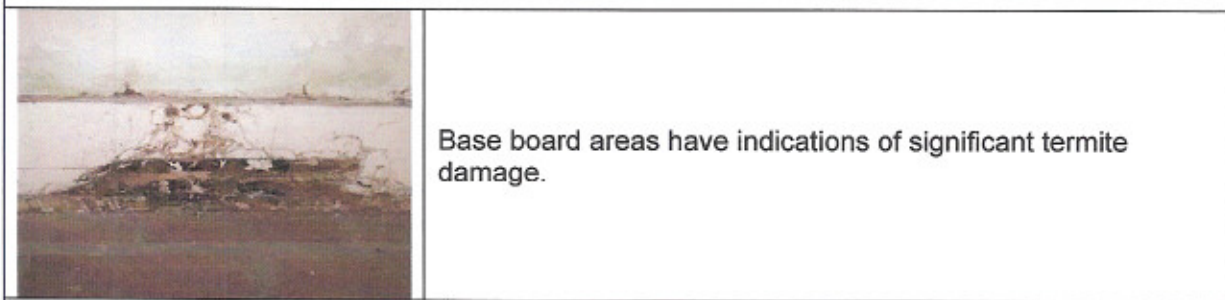
Base board areas have indications of significant termite damage.

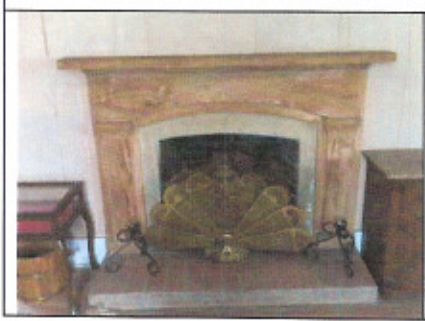
08-08-05
The fire place should be sealed or removed to ensure it is never used.

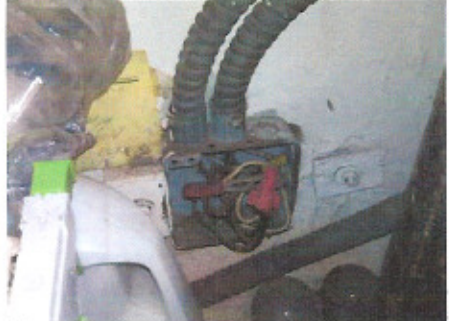
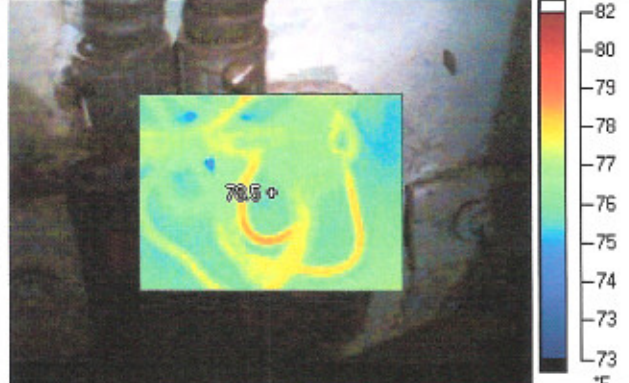
Exposed Wires, Closet of Restroom

08-08-06
Worn insulation and exposed junction box is causing heat build-up in the wiring.

- Enclose junction box, replace wiring leading to junction box.
- Do not use this junction box until repaired..

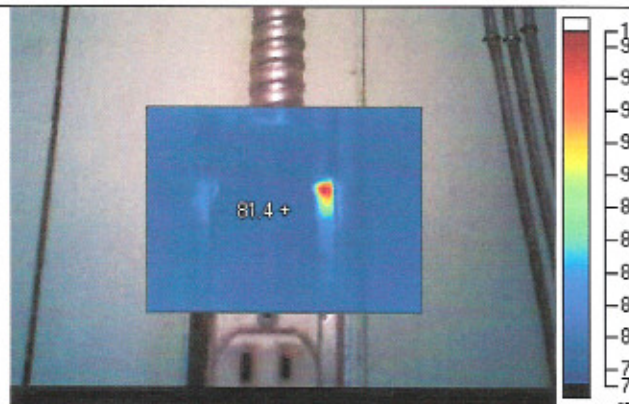
<p>Electrical Outlet, Storage Closet Bedroom.</p>

08-08-07
Damaged insulation, possibly due to water intrusion is causing heat build-up in outlet. Inspect, clean, and tighten all connections.

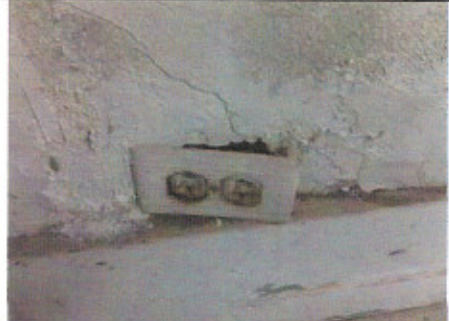
<p>08-08-08 Water damage has caused the electrical outlet in the bedroom to pull away from the wall.</p> <ul style="list-style-type: none"> • All damaged electrical outlets should be removed or repaired in order to prevent electrical shock and to reduce fire hazards. .
---	---
