MICHAEL WHITE ADOBE
HISTORICAL RESOURCES TECHNICAL REPORT

Prepared for
San Marino Unified School District

Prepared by
Chattel Architecture, Planning & Preservation, Inc.

August 4, 2009

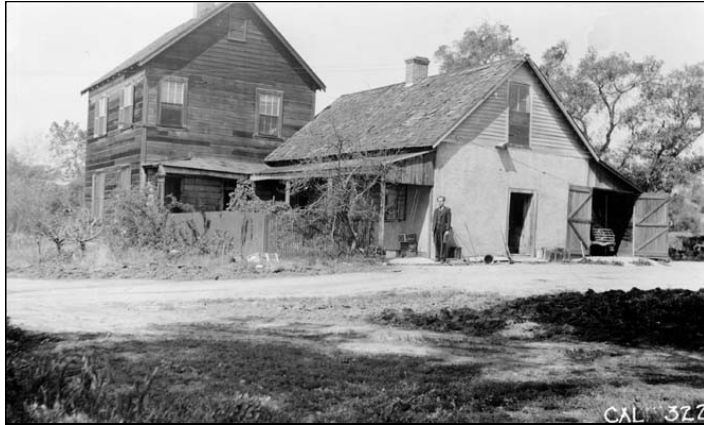
Figure 1: South elevation (left) and north elevation of south wing (right), note two story wood frame addition, view northwest (Historic American Building Survey, 1936)

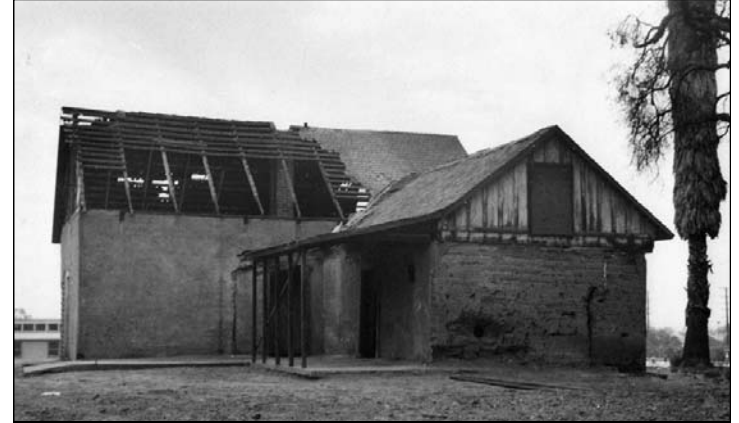
Figure 11: North elevation, south wing (left) and north wing (right), view southwest (San Marino Historical Society, 1952)

In contrast, photographs from 1952 show large areas of deterioration with significant portions of the roof missing in the south wing (**Figures 11-16**). It is possible the Adobe suffered damage due to the July 1952 Tehachapi earthquake. The lean-to has been removed in these photographs, as well as the enclosure around porch along the east elevation. In addition, door leaves and window sash have been removed.

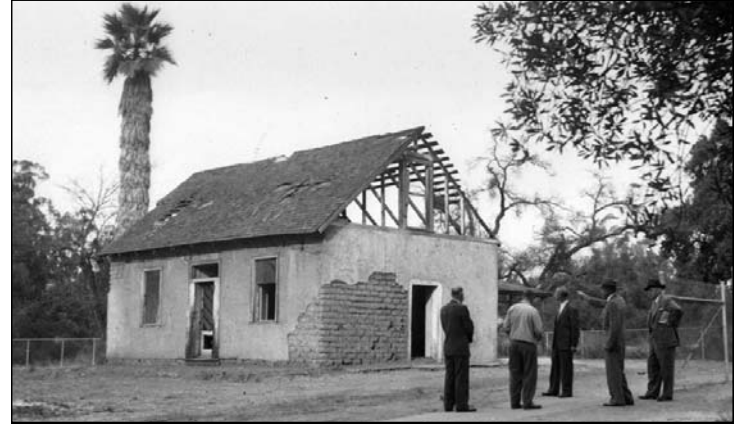
Figure 12: South and east elevations, view northwest (San Marino Historical Society, 1952)

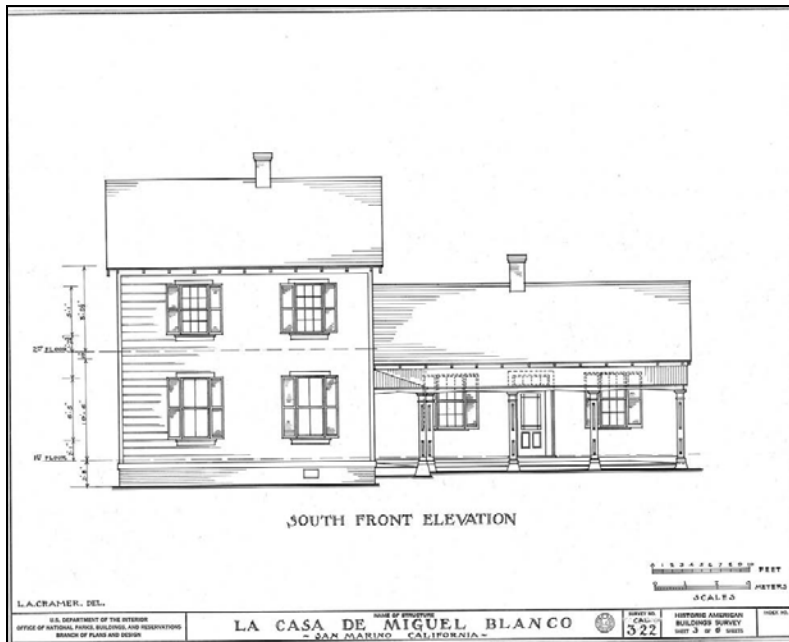
Figure 24: Drawing of "South Front Elevation" (Historic American Building Survey, 1936)

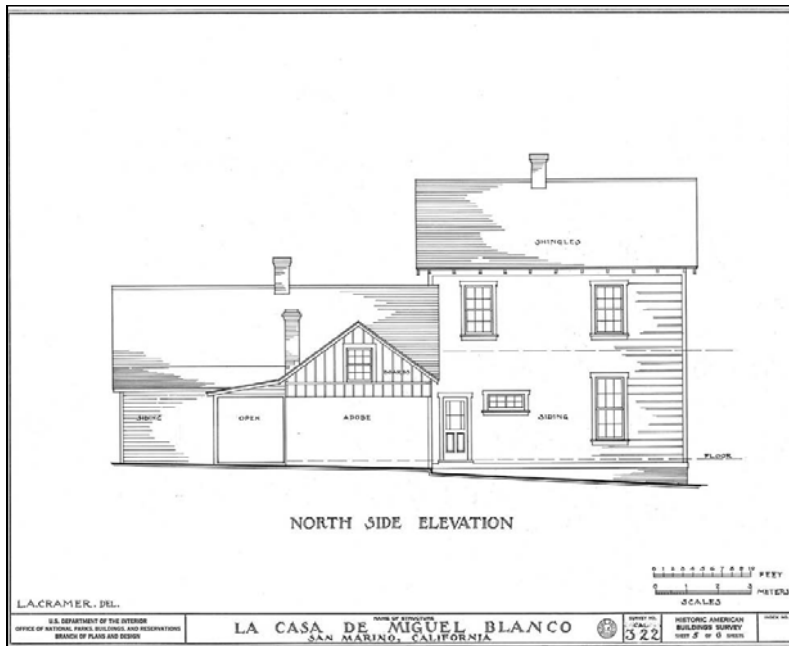
Figure 26: Drawing of "North Side Elevation" (Historic American Building Survey, 1936)

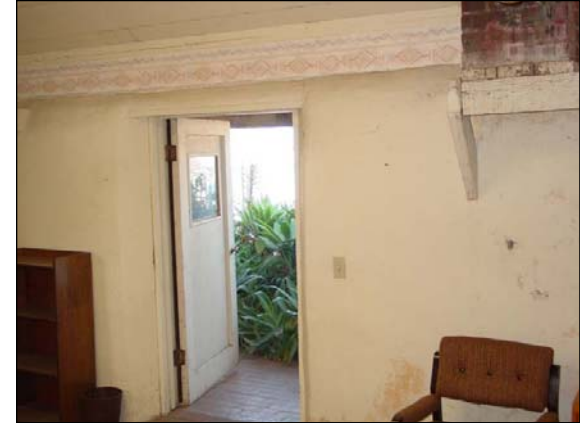
Figure 45: Interior of north wing, view northeast, note evidence of chimney remnant in upper right corner of photo, (CA, 2008)

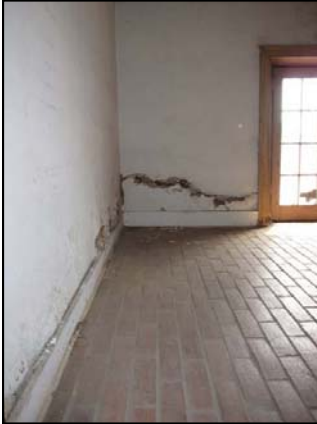
Figure 54: Interior of south wing, east elevation (background), note cracked wall (CA, 2009)

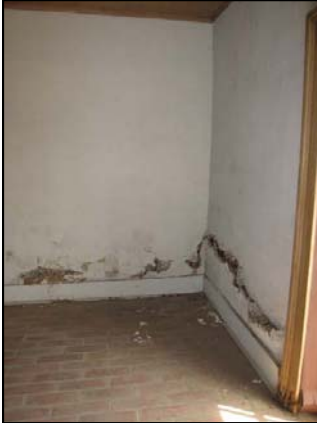
Figure 55: Detail of cracked wall (CA, 2009)

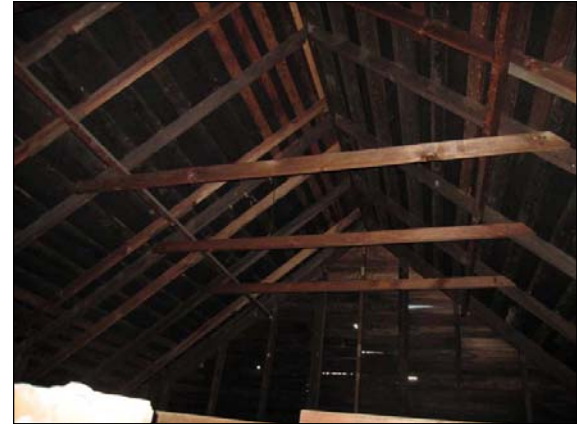
Figure 56: South wing attic, view west, note contemporary roof framing (CA, 2009)

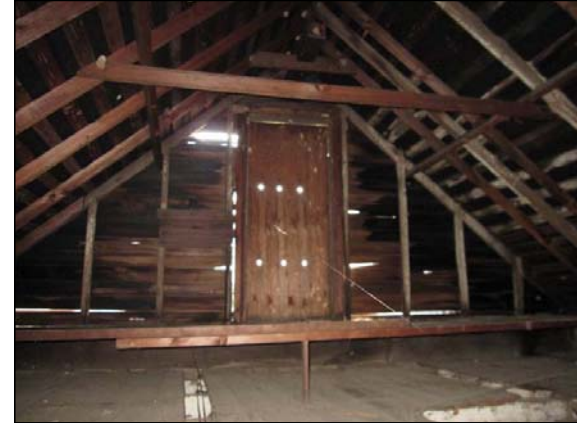
Figure 57: South wing attic, view east, note contemporary roof framing (CA, 2009)

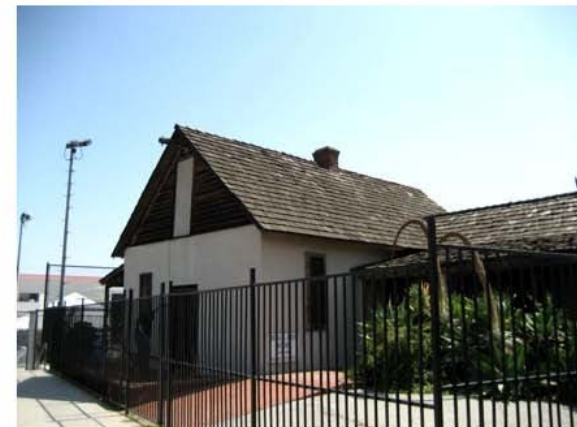
Photo 1 - East elevation of the Michael White Adobe. Wood gable end with large door possibly an old stairway or hayloft.

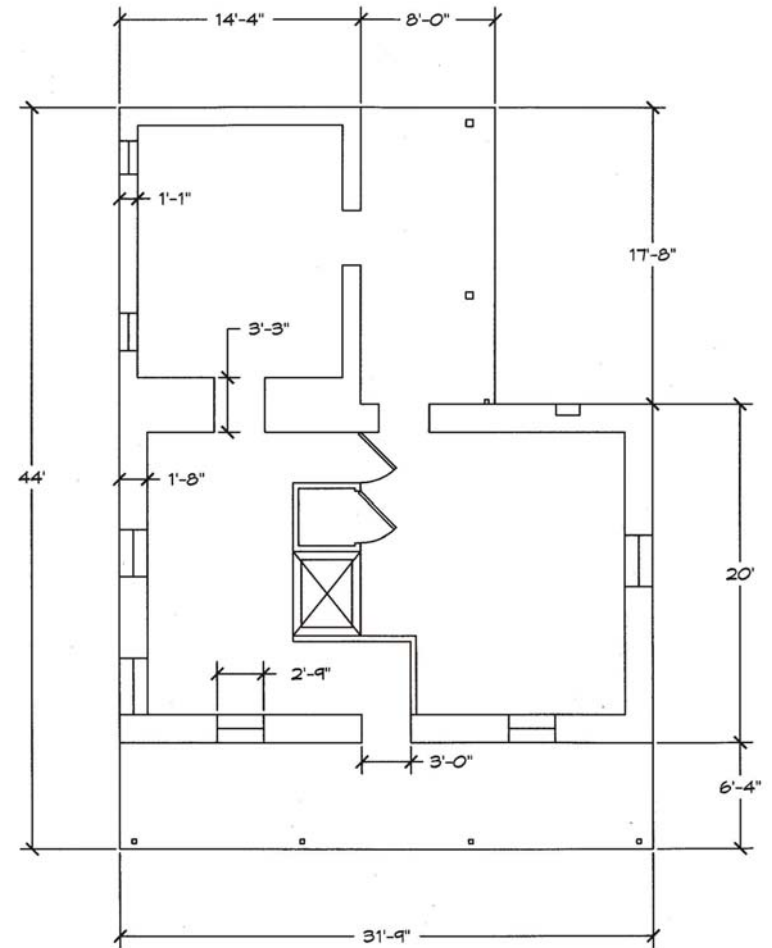
Figure 1 - Plan of the Michael White Adobe in San Marino.

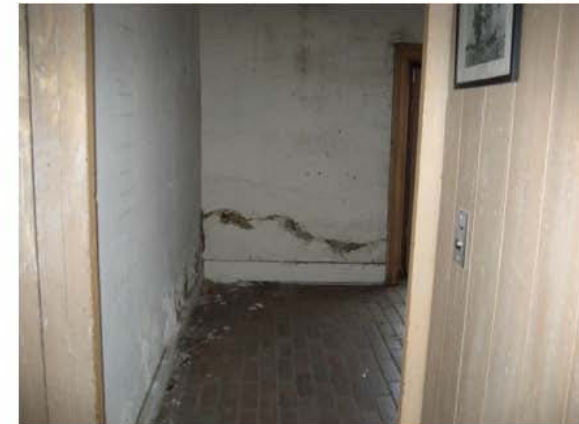
Photo 5 - Brick floor. Water damage on wall. This is caused by moisture rising from the ground.

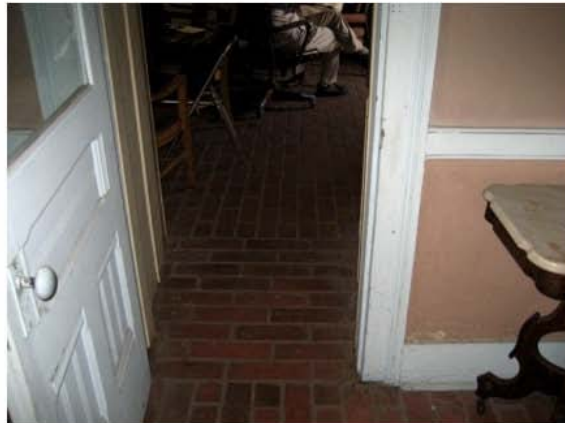
Photo 7 - Details of early door and trim. Note brick floor, unusual for an adobe.

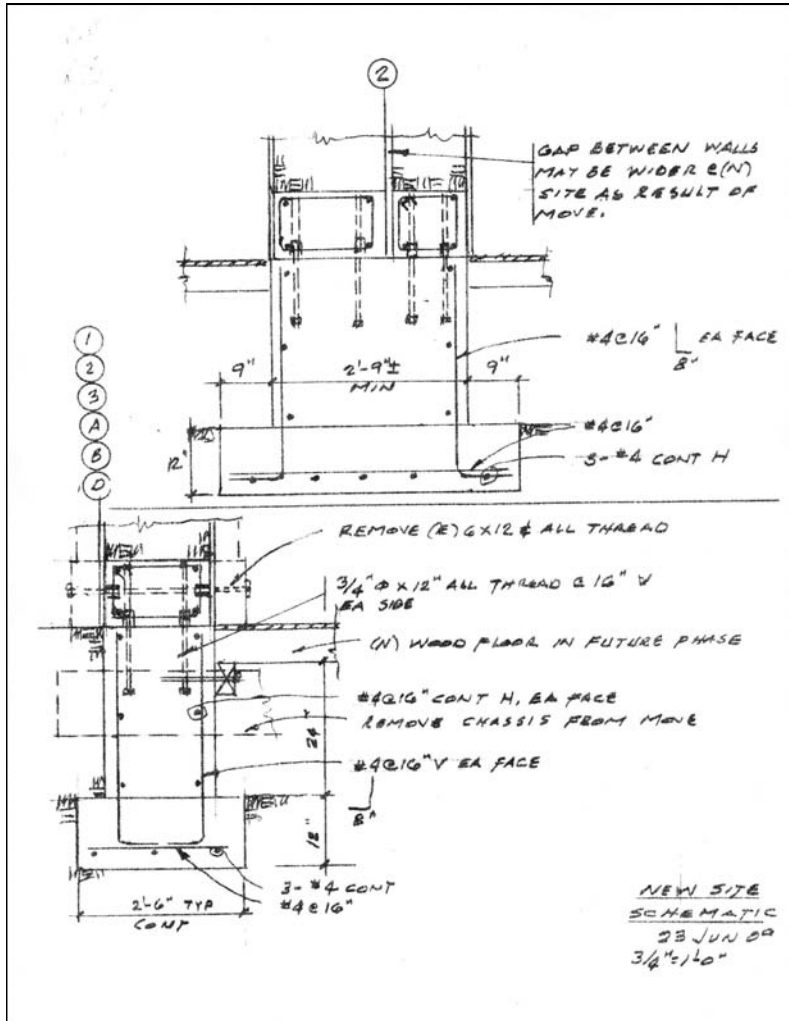
Figure 82: New (receiver) site schematic for Adobe relocation. (Drawing prepared by Michael Krakower)

When the Adobe is relocated it will be placed on a new foundation as shown in a Krakower sketch. Grading, compaction and other preparation of the receiver site including stubbed out utilities would need to be further documented. It should be noted that the relocation scenario does not include full rehabilitation of the Adobe, but rather stabilization only. Stabilization in the relocation involves placement of the adobe structure on the new foundation with sufficient site work to ensure water flow away from the adobe structure, construction of new roof structures and sheathing, and patching of exterior surfaces as necessary all to provide a watertight assembly. It is anticipated that a new chimney, flooring, and other work will be required to fully rehabilitate the relocated Adobe for use.
